Esthetic Management Of An Anterior Avulsed Primary Teeth With Groper's Appliance In A 3 Year Old Child: A Case Report

Abstract

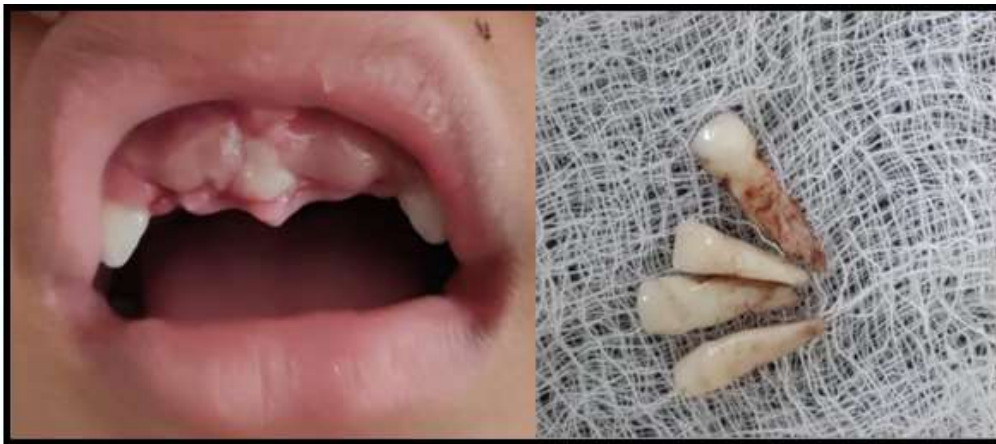
grilled door that resulted in dental trauma. The trauma occurred 12 hours ago. The child had already been seen by the medical staff of the emergency unit of a local hospital who had detected no neurological damage or medical complications. Her parents had let the avulsed teeth dry in a piece of paper and brought it to the clinic. Any concomitant systemic disease is not defined by the patient's parents. The intraoral examination revealed that all the maxillary anterior primary teeth (51, 52, 61, 62) were (Figure 1)

Figure 1: Intraoral view and Avulsed anterior primary teeth

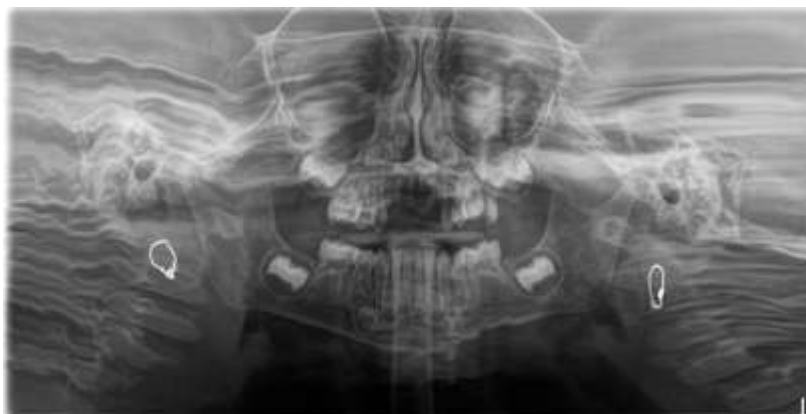
Radiographic Examination: OPG revealed missing 51, 52, 61 and 62. The underlying tooth-like structure indicated the presence of 11 and 21 at 5th Nolla's stage. The remaining alveolar bone thickness from the underlying tooth structure to the crest was measured to be 4 mm. (Figure 2)

Figure 2: Ortho pan tomogram

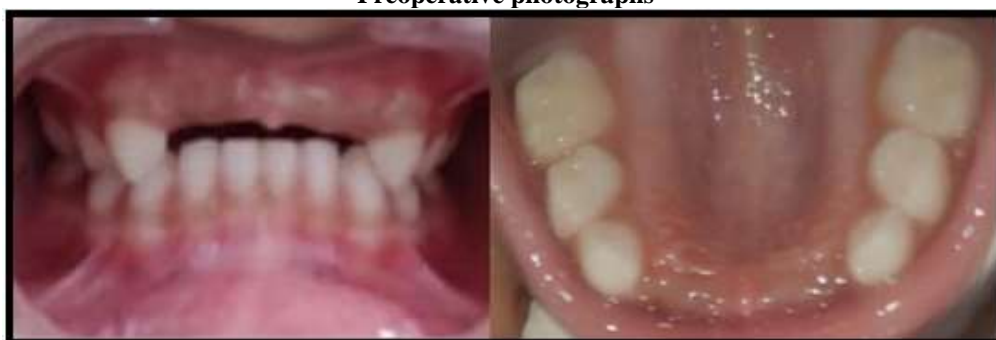
Preoperative photographs

FRONTAL VIEW OCCLUSAL VIEW

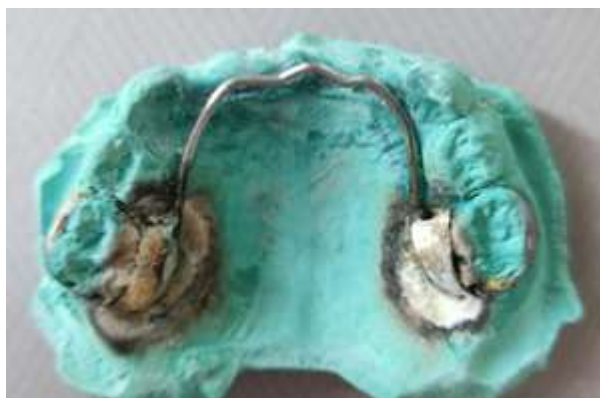
Figure 3: Gypsum model

Cast was poured with Type III gypsum product-Dental stone. Extending from one band to other band, a stainless steel wire (1.00 mm) framework was made and wire ends were then soldered to the corresponding molar bands of the maxillary teeth. (Figure 3)After applying separating media, the cold cure acrylic material being flowed from the palatal area to the labial vestibule and extended to the posterior 64 region over the arch wire. The avulsed tooth was rinsed in normal saline, and the natural tooth was sectioned in a horizontal plane at the level of the cement-enamel junction (Figure 4) with the help of an abrasive disk under constant irrigation. Complete extirpation of the pulp was done from the cervical area. The crown portion was then contoured with a flame-shaped air-rotor bur. (Figure 4) the entire pulp chamber was etched with 37% phosphoric acid, followed by rinsing for 15 seconds and attached to the U loops created with acrylic resin with 1mm of gingival clearance. (Figure 5) After fabrication of the appliance, it was removed from the cast and ready for an intraoral try-in. (Figure 5)

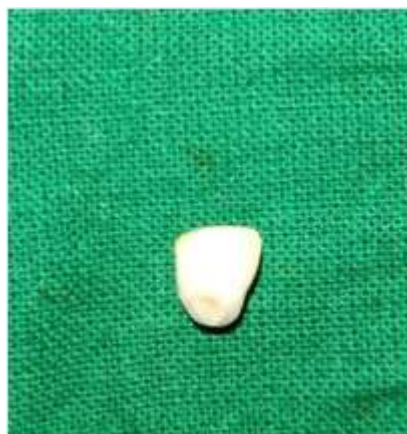
Figure 4: Outline of the natural teethafter sectioning

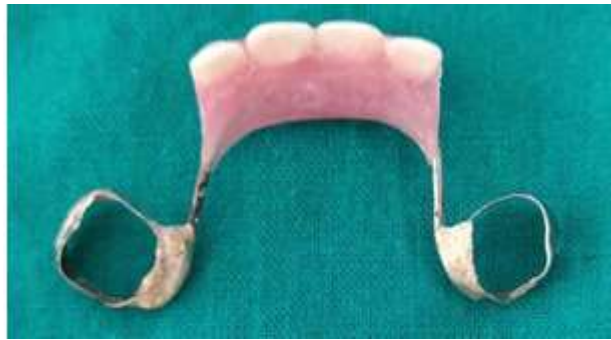
Figure 5: View of the Groper's appliance with natural teeth before cementation

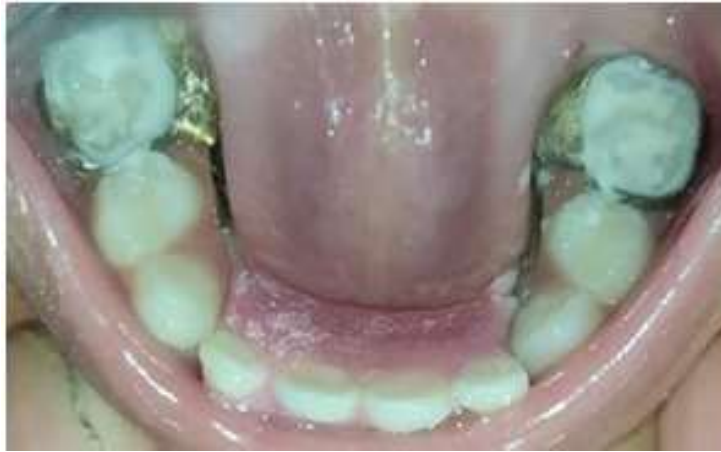
Figure 8: Occlusal view

In Second Appointment: Required adjustment, trimming and polishing was done, and finally, appliance was cemented with luting GIC through the molar band on 55 and 65.(Figure 8)The patientwas instructed to maintain proper oral hygiene especially cleaning of acrylic area afterevery meal. The patient was also instructed to visit after 1 month for follow-up and in case of any breakage of appliance, report immediately. The patient was then followed every month for three successive months and problem of accumulation of food debris and plaque was observed.
